Rehabilitation of RCC Water Tank at a Tata Group Company

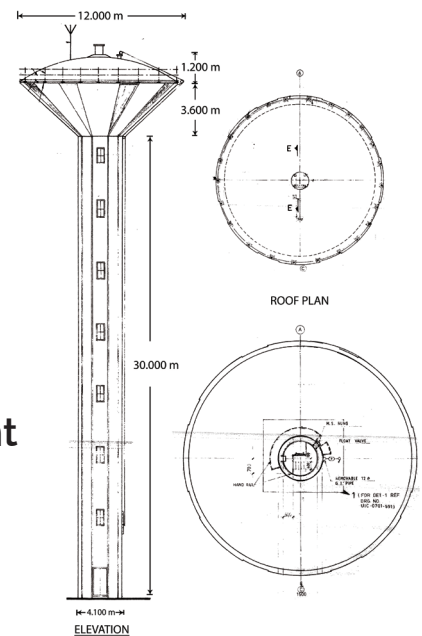
To assess the structural integrity of the water tank using the rope access method, non-destructive tests (NDT) were conducted. Rope access technicians were instrumental in reaching these areas, ensuring a comprehensive evaluation.
