Rehabilitation of RCC Water Tank at a Tata Group Company

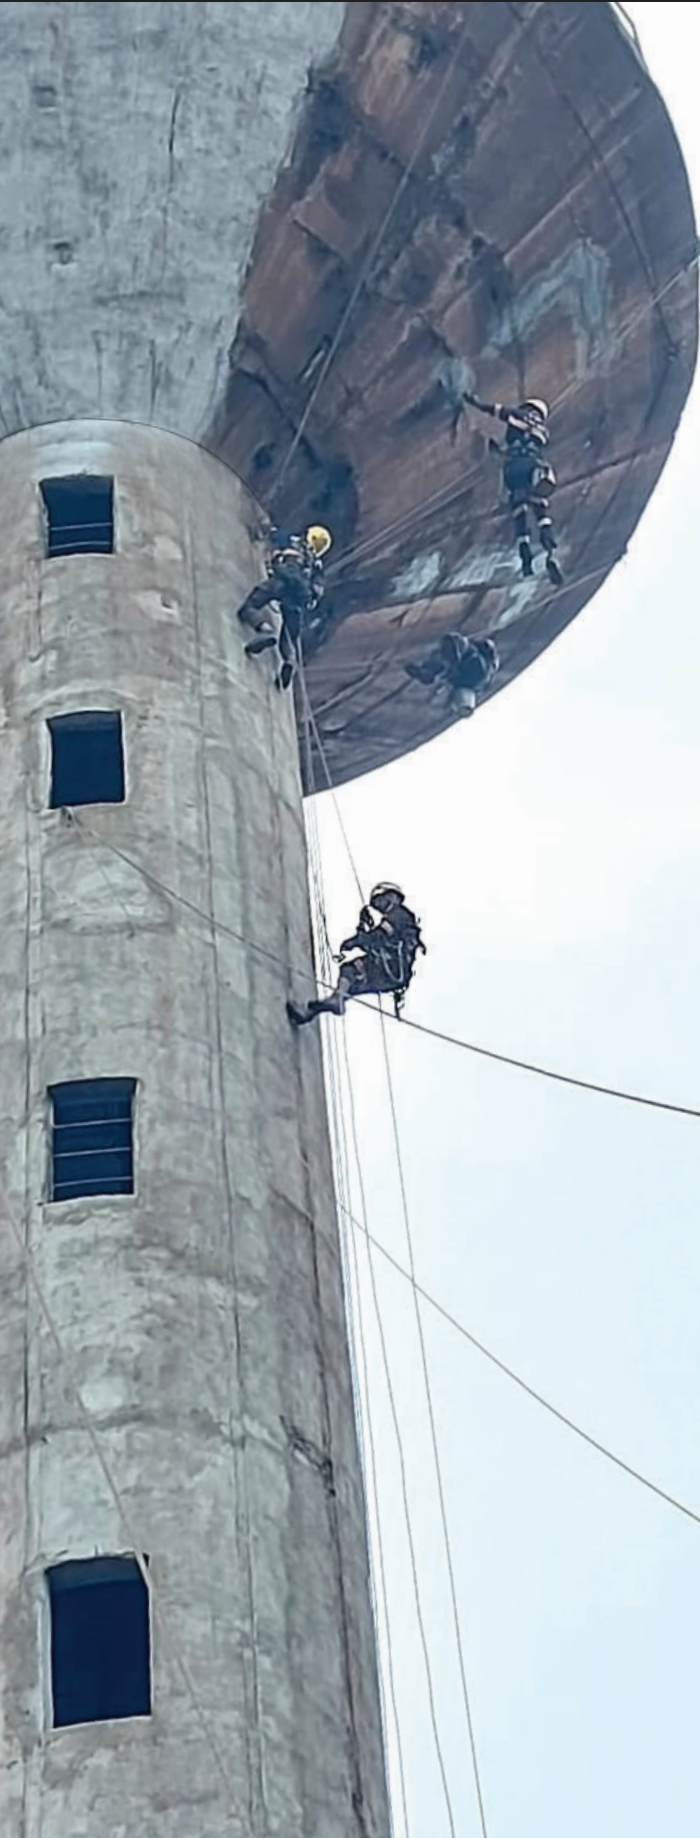
- Cracks of varying widths were observed in different areas of the tank, with a higher concentration on the outer side wall compared to the inner side wall.
- Indications of chlorination and degradation of concrete inside the upper water tank.

Rebound hammer and carbonation tests indicated potential weaknesses in the structure.

Ultrasonic pulse velocity tests confirmed the presence of cracks and revealed deterioration of concrete in various areas.
